# Assessment and Decision Frameworks for Seawall Structures

Appendix  
D

Site Field Data Collection

## Appendix D Site Field Data Collection

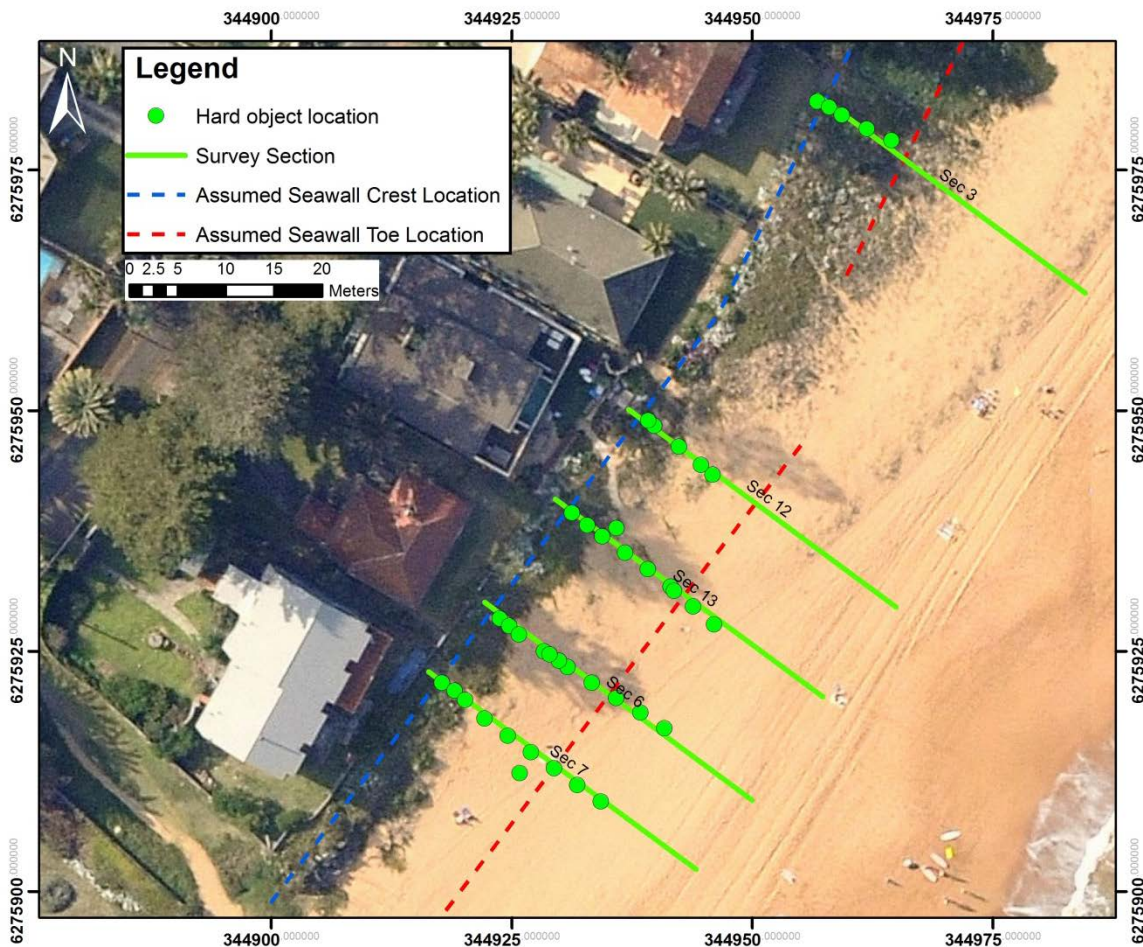
**Figure 2.6 Hard Object Location and Predicted Crest and Toe Level Location**

The rock locations as predicted by GPR analysis were compared to the hard substrate levels as recorded from drilling refusal depths. In most cases, the borehole data confirmed the results of the GPR. In isolated locations both the boreholes and GPR indicated the presence of hard objects that were discontinuous with the surrounding area. The interpretation of GPR sub-surface mapping relied heavily on the experience of the 'interpreter' with isolated hard objects generally more clearly identifiable than clusters of rocks. Objects exceeding 3 metres of depth were not identified by the GPR screening; the use of other antennas (>500 MHz) may enable objects at greater depths to be detected. On the basis of this comparison, for coastal applications, WRL recommends the use of the GPR technology be supplemented by a dataset of test boreholes at selected locations.

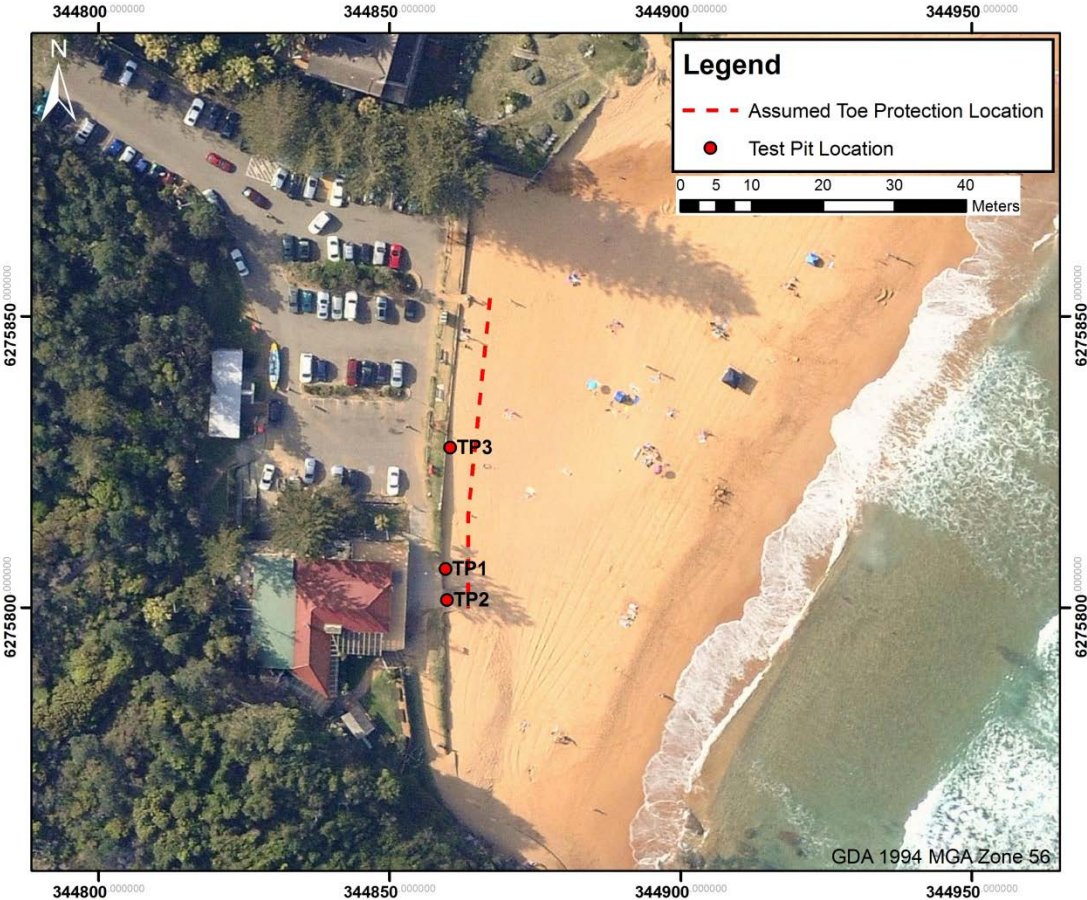
Figure 2.9 Location of Test Pits in Front of Bilgola SLSC Seawall

The location of the test pits is shown in Figure 2.9. Based on the test pit investigation, the seawall appears to be founded on sand with toe levels of approximately 2.0m AHD. Excavation exposed a toe protection constructed using flat rock blocks (high length-to-thickness ratio) densely placed in a double layer at a level of approximately 3.0m AHD. Photos of the excavation test pits are shown in Figures 2.10, 2.11 and 2.12.

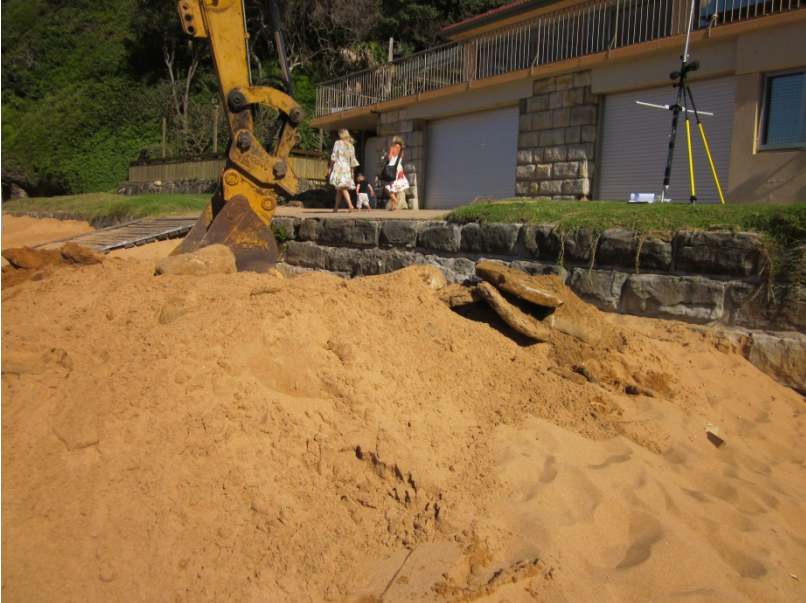
**Figure 2.11 Excavation of Seawall Toe Protection Blocks**

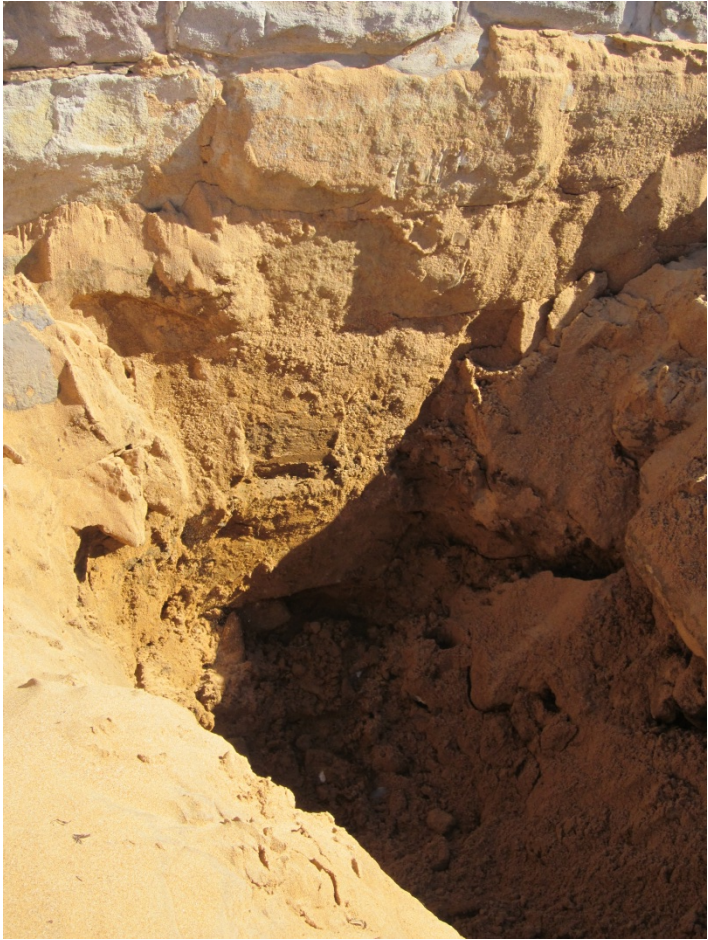
**Figure 2.12 Seawall Toe Exposed at Test Pit TP1**
