Assessment and Decision Frameworks for Seawall Structures

Appendix
G

Case Study Gold Coast

Appendix G Case Study – Gold Coast

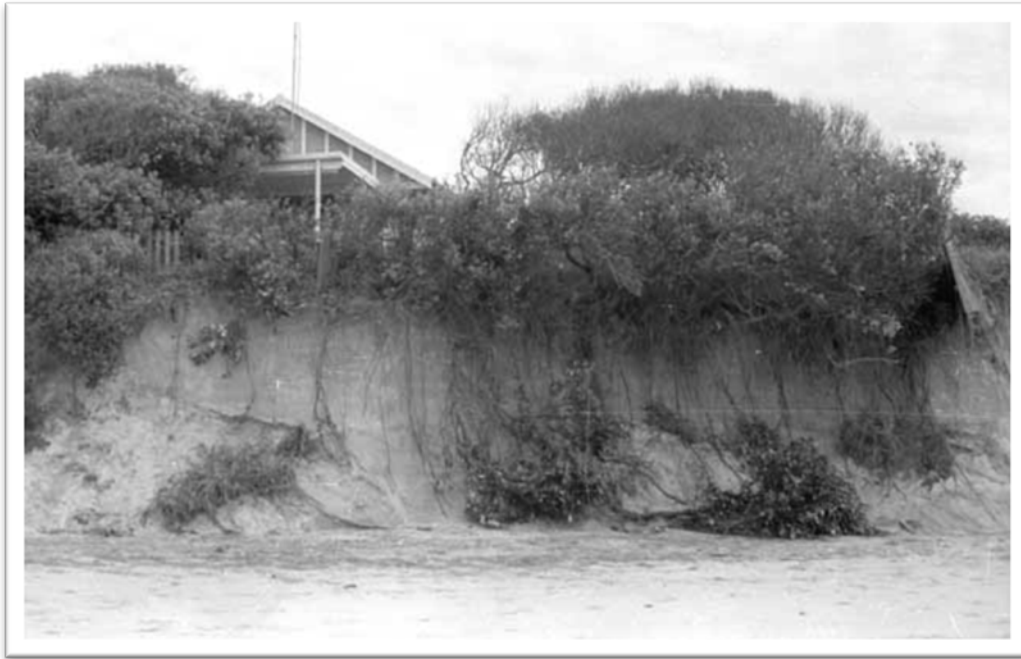
Figure 3 Dune cut, 1967 Storms

The 1967 cyclones, seven back-to-back, caused extensive damage to all of the southern Queensland beaches. In areas with wide, well-vegetated dunes the erosion was slowed, but eventually the dunes collapsed during the battering every high tide (Figure 3).

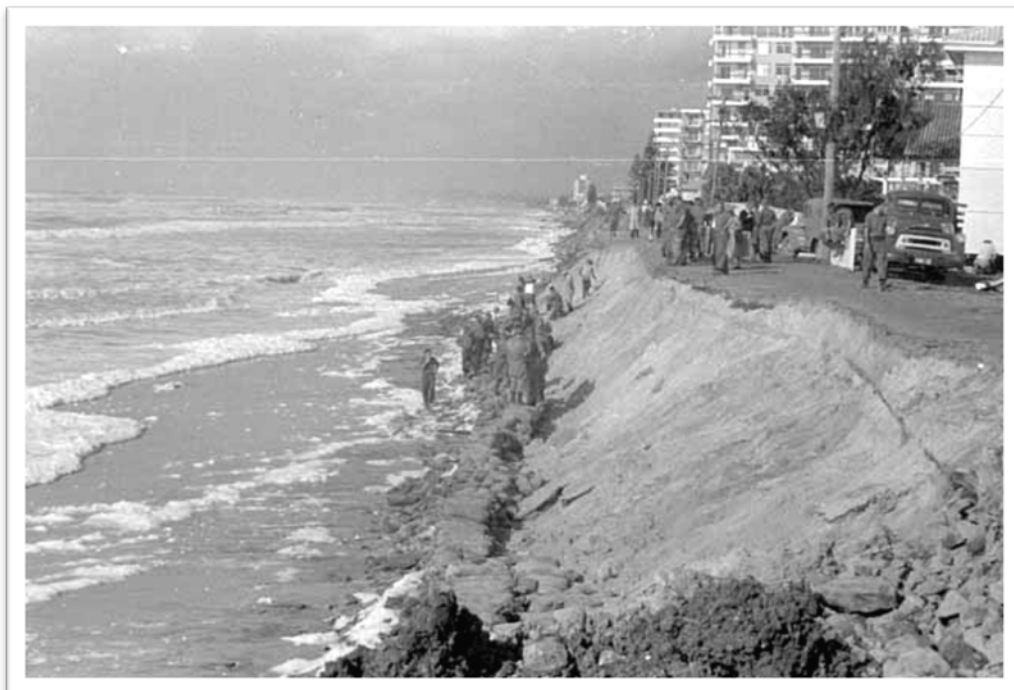
Figure 4 Surfers Paradise Esplanade, 1967

It was not just private beach houses and lifesaving clubs that were threatened - the public esplanade roads that had been designed well back from the beach by the early state government planners were severely damaged. This meant that services such as power and water were cut and access to properties was cut off. Surfers Paradise esplanade is shown in Figure 4.

The army was dispatched to deal with the disaster. They brought with them their familiar tool, hessian sandbags (Figure 4 and 7). Larger plastic fertiliser bags were also used by Council and residents but proved less effective due to their low coefficient of friction. Gold Coast City distributed sandbags to owners who filled them using readily available sand from their yards.

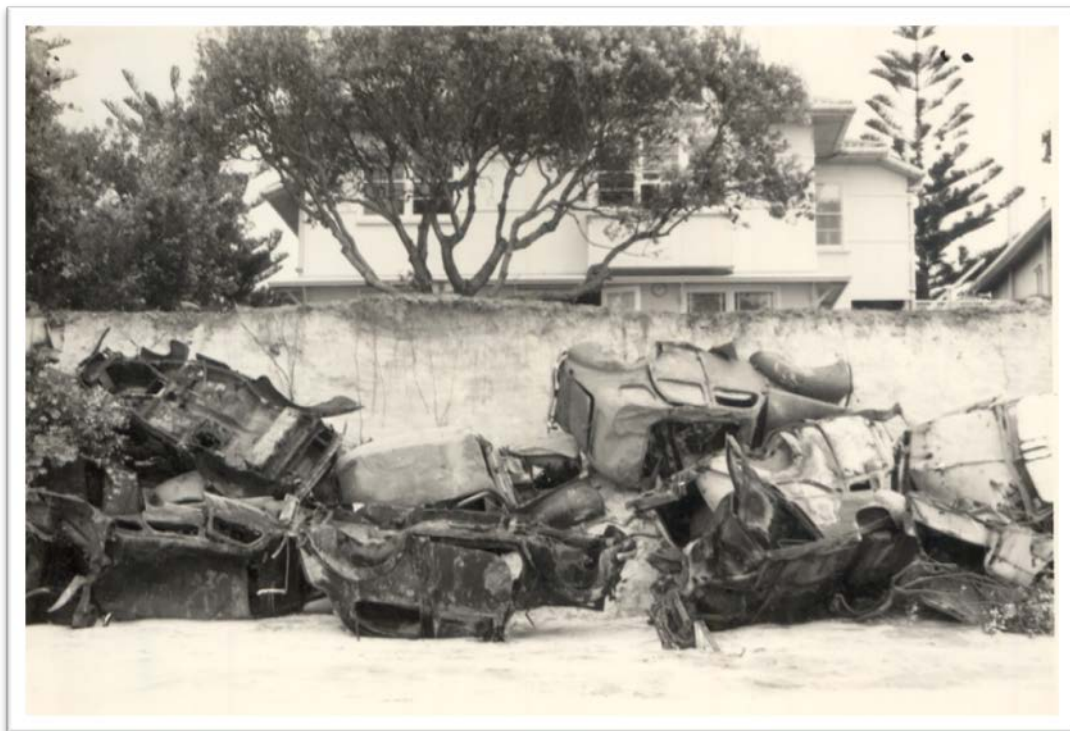
Figure 5 Use of car bodies to protect against storm erosion in 1967
(Source: GCCC)

- boulders
- car bodies (Figure 5)
- concrete rubble
- concrete slabs (including collapsed swimming pools)
- drums filled with concrete
- gravel
- masonry bricks and blocks as rubble
- plastic sheeting
- pavers
- sand
- sandbags
- timber walls and groynes.

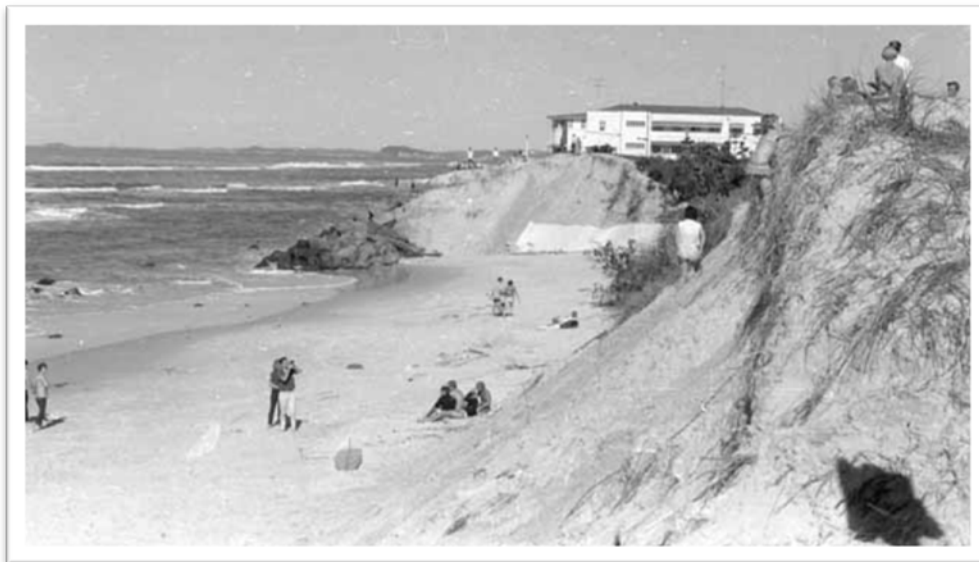
Figure 6 Erosion without protection compared to with adequate protection

While they lost the beach, the extent of the erosion was curtailed. Erosion occurred unabated up and down drift without any significant increase in the extent (Figure 6). Recovery of the beach occurred after the storms in all areas. One problem was that with the cyclonic rains, access to quarries for suitable rock was limited.

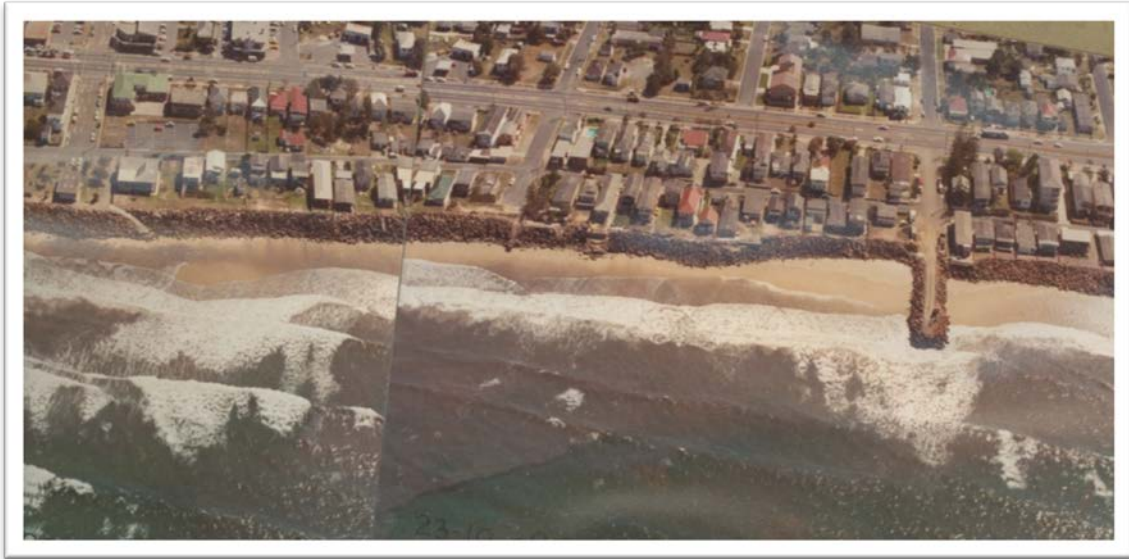
Figure 8 Seawall exposed at Palm Beach, 1989

The natural dynamics of beach evolution imply that seawalls are covered by sands during accretionary periods or following artificial replenishment schemes, and more or less exposed during erosive periods (Figures 8 and 9). The location of the protection wall thus delimits a safer zone of use and avoids the projection of properties further on the beach. The Gold Coast seawall is thus regarded as the last line of defence against the sea (Smith, 1987). There is, however, uncertainty regarding the effectiveness of the wall given that there have been far fewer significant erosive events since its initial construction.

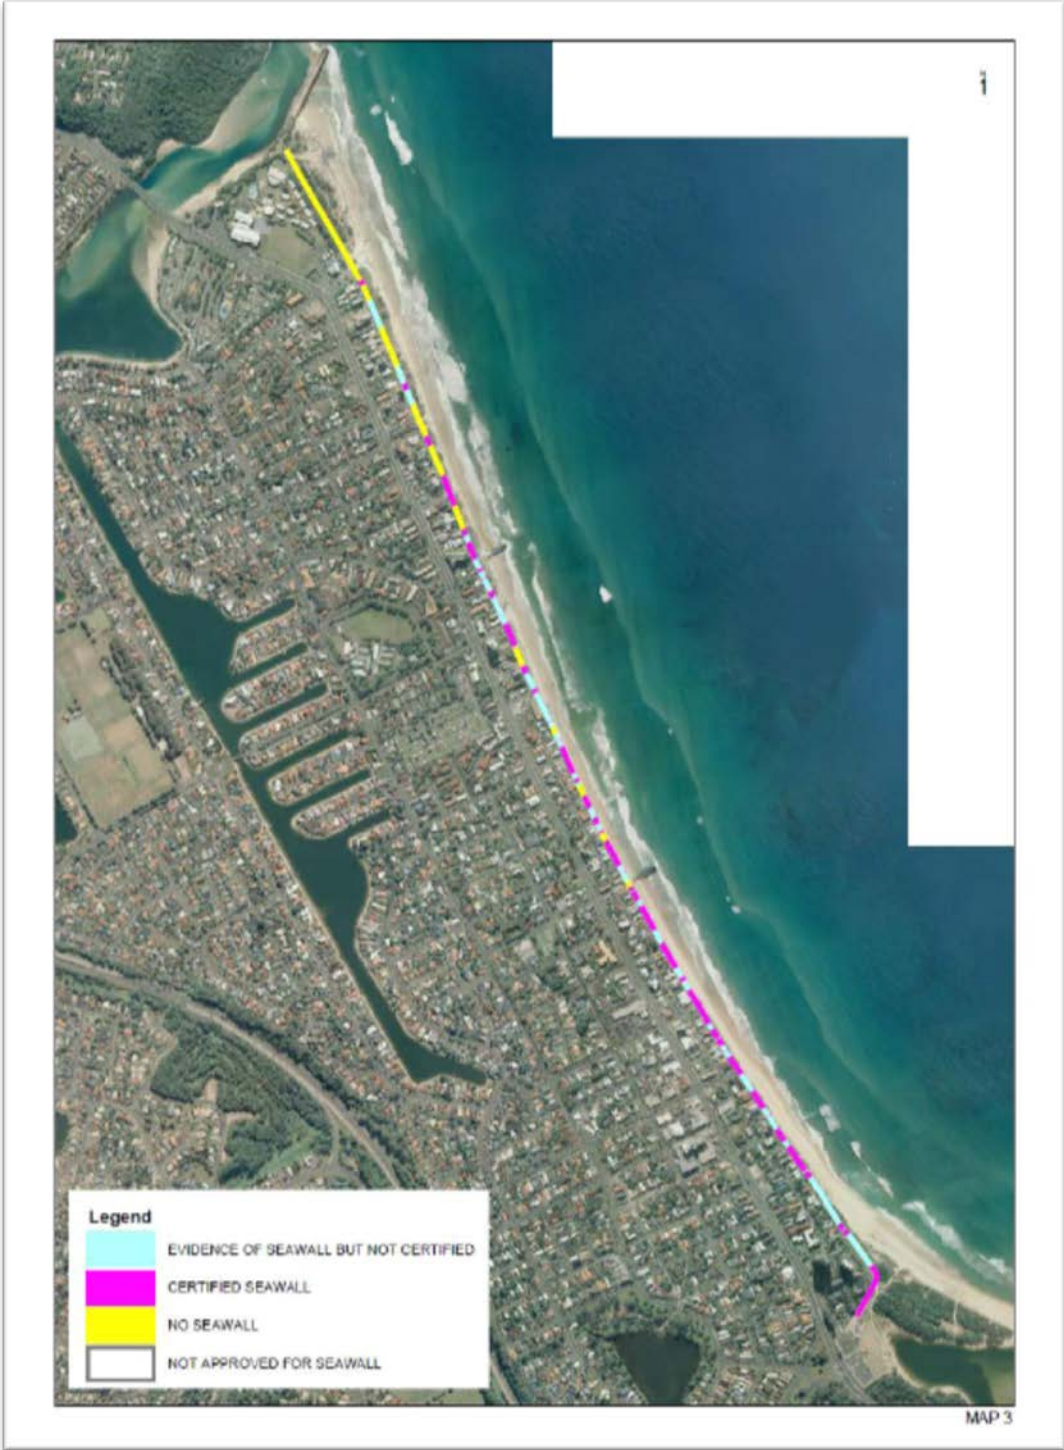
Figure 10 Status of the Seawall at Palm Beach
(Source: GCCC, 2012)

Council's records indicate that there are currently 17.7 km of the 31.5 km (56%) of beachfront with at least some evidence of a constructed seawall, including 11.1 km of 22.5 km (49%) of public seawall and 6.6 km of 8.9 km (74%) of private seawall. An example of the status of the seawall is given in Figure 10 for the Palm Beach section of the coastline.

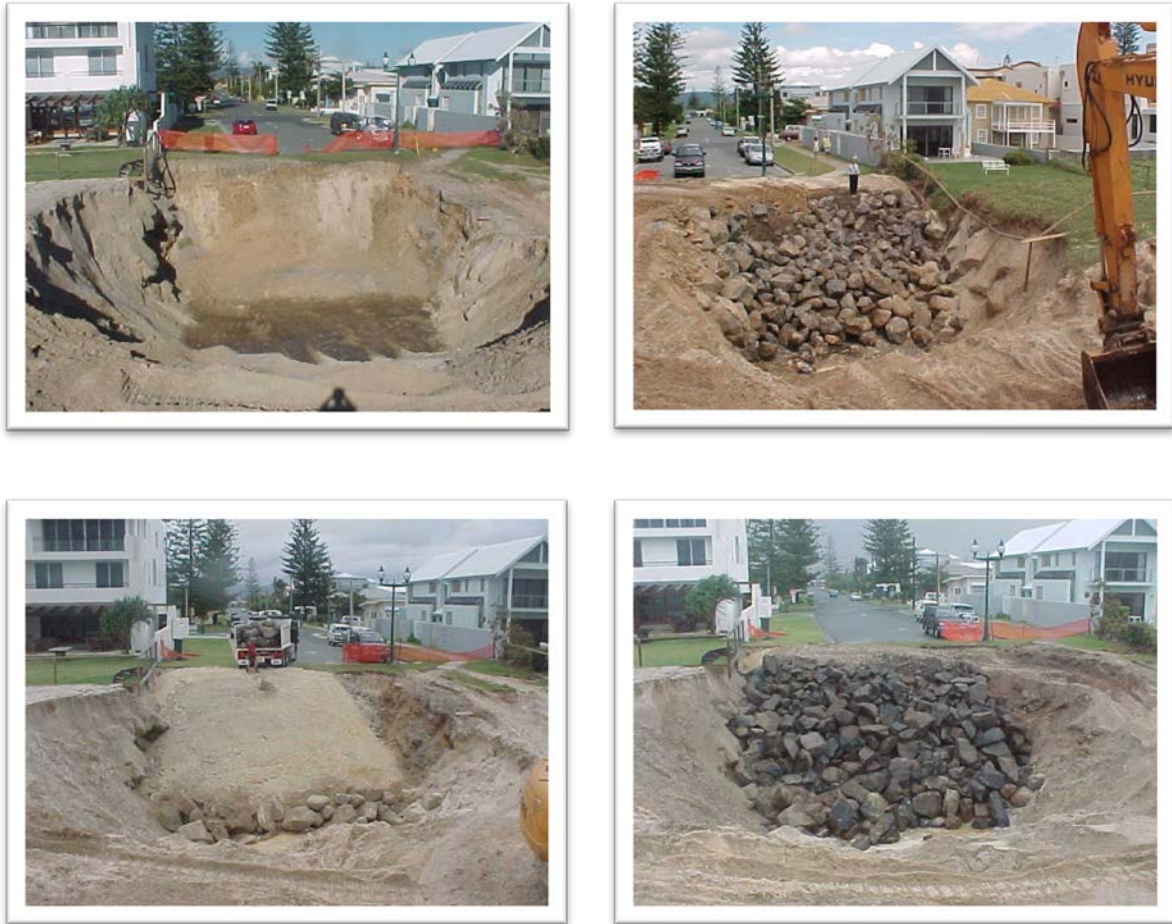
Figure 13 Construction of a seawall on a Palm Beach street end

Gold Coast City Council provides the following guidance for the construction of a wall as shown in Figure 13.

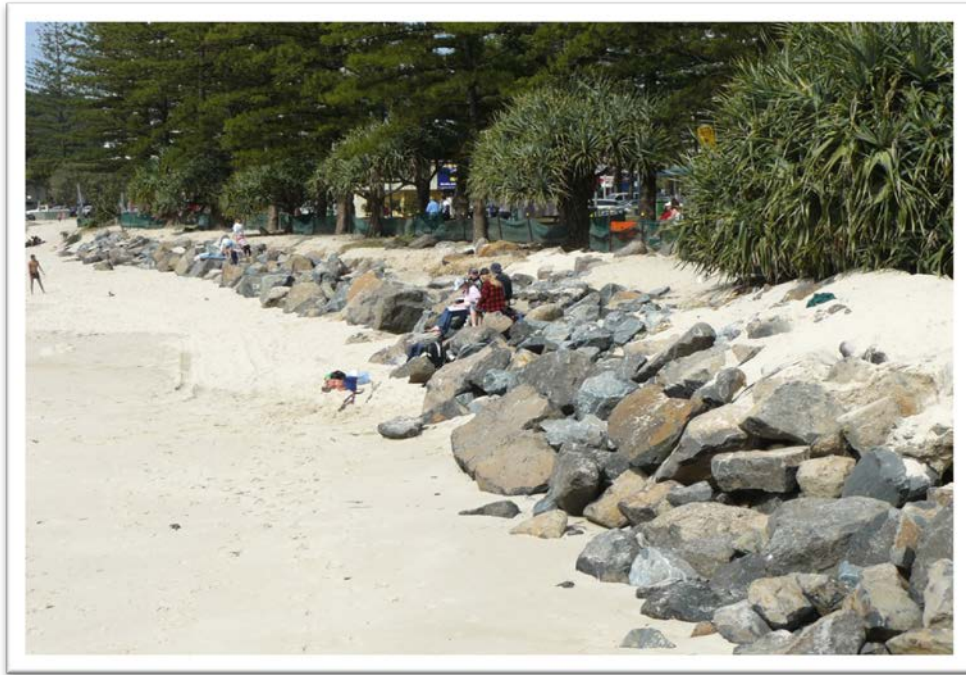
Figure 14 Exposed seawall at Burleigh Beach built to protect the adjacent Justin Park, 2008

When public seawalls become exposed (Figure 14), Gold Coast City Council maintenance personnel assess and organise the most appropriate means of rectification, which usually involves placing additional sand at the exposed area. If the maintenance supervisor considers that the exposure is major, he will discuss the matter with Engineering Assets and Planning (EAP) (asset owner) staff to discuss the means of rectification and funding.
