# Assessment and Decision Frameworks for Seawall Structures

Appendix  
D

Site Field Data Collection

## Appendix D Site Field Data Collection

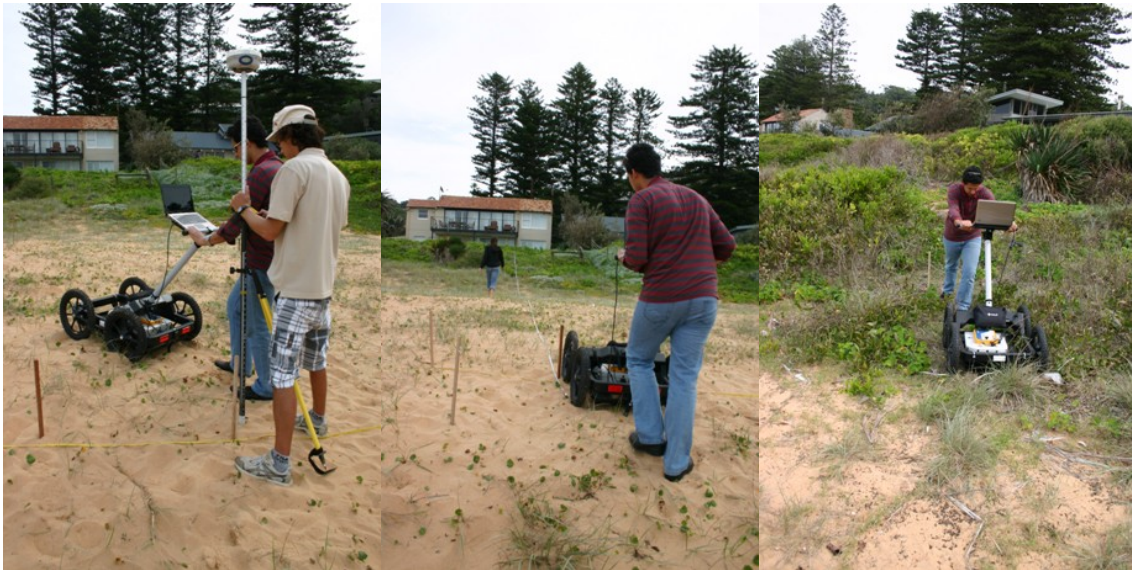
Figure 2.4 Photos of GPR Survey and RTK-GPS Survey

The survey was undertaken by Dr Leonhard Bernold, Mr Amir Tavakolitahezavareh and Mr Alessio Mariani on 28 April 2012. Ten sections (Sections 1-8 and Sections 12-13) across the dune fronting Allen Avenue properties were surveyed using GPR screening. The section locations (Figure 2.3) were selected in relation to the accessibility of the terrain, as the presence of thick vegetation in some locations did not allow the passage of the GPR equipment. Section lengths varied from approximately 15 to 30 m in a generally south-east to north-west direction across the assumed seawall location. Each section was topographically surveyed using WRL’s RTK-GPS survey equipment. Measurements of sand density and water content were also made during the investigation. Photos of the survey are shown in Figure 2.4.

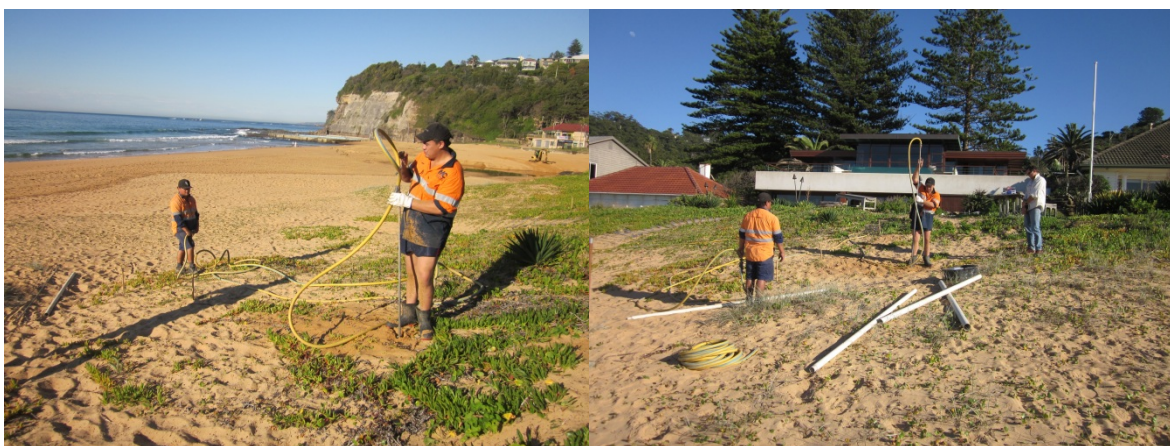
Figure 2.5 Borehole Drilling on the Dune Fronting Number 5 Allen Avenue

Drilling of boreholes was undertaken by MacDonald Contracting Australia Pty Ltd on 10 May 2012 under the direction and supervision of WRL staff Mr Alessio Mariani and Mr Hamish Studholme. Test boreholes were used to support and validate the GPR survey findings. The unconsolidated dune sands allowed jet air drilling of a 50mm PVC casing into the sand down to refusal (i.e. until a hard substrate was reached).

A total of 60 test boreholes were drilled at 3 metre intervals along selected sections previously surveyed using GPR (Sections 3, 6, 7, 12 and 13). Locations of these sections are shown in Figure 2.3 and test borehole logs are presented in Addendum II. Borehole locations were topographically surveyed using WRL's RTK-GPS equipment. For each borehole, relative depths of refusal were recorded and absolute levels (m AHD) could then be inferred using the topographic data from the RTK-GPS survey. Photos of the drilling are shown in Figure 2.5.
